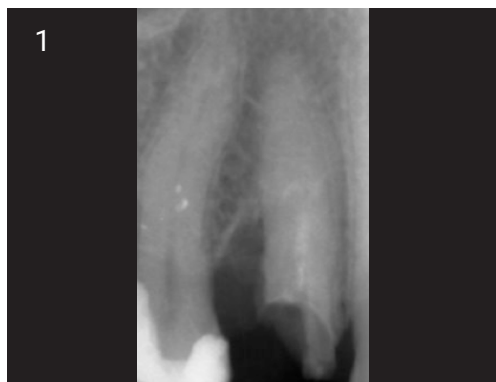
1. Pre-op showing bone loss from root fracture.

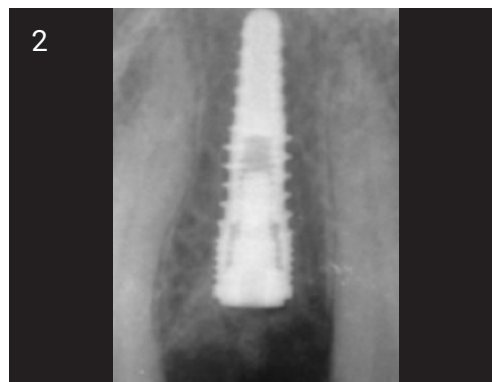
2. Implant placed and grafted with EthOss®.

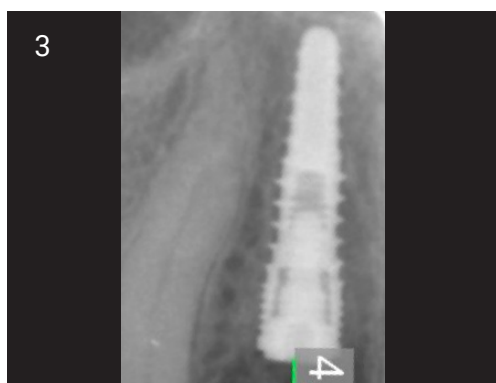
3. Implant loaded at 12 weeks - bone growing over implant.

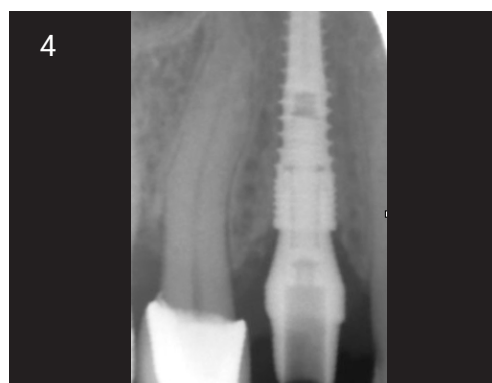
4. Loaded 6 months.

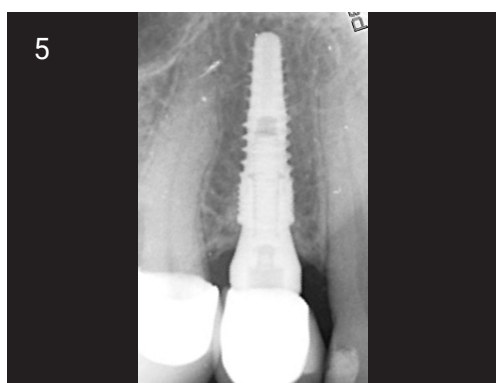
5. Loaded 3 years showing further bone improvement.
