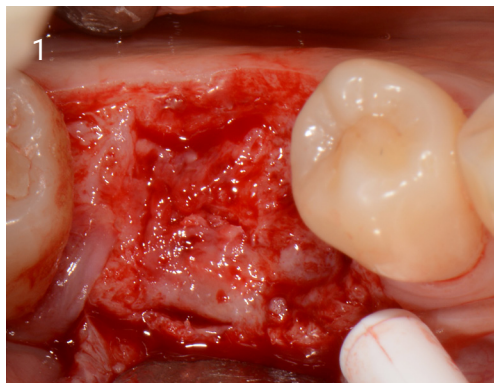
1. 3 weeks post extraction flap raised to show granulation tissue.

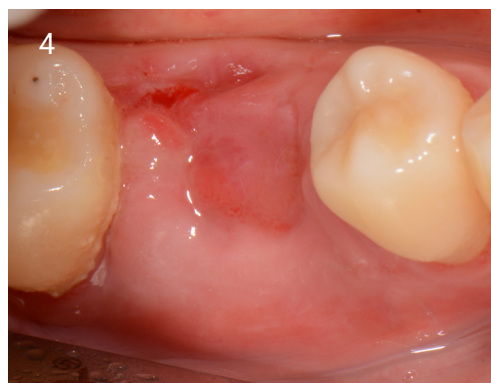
4. Healed site 5 days later - sutures removed.

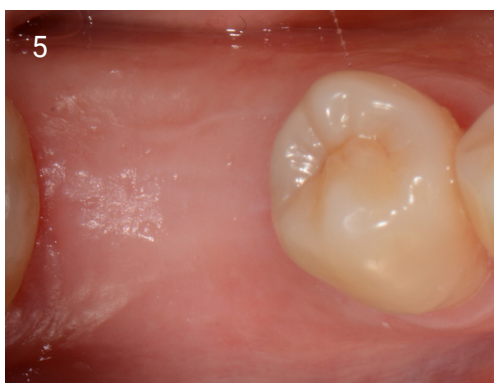
5. 12 weeks later healed site.

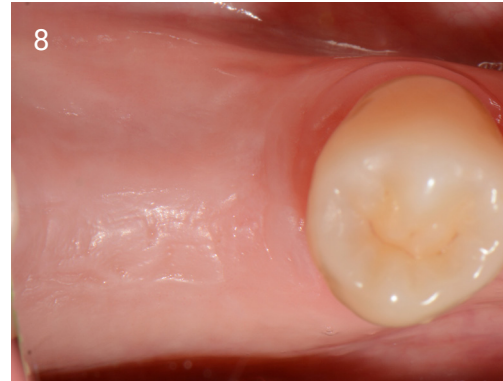
8. Ready to load at 10 weeks , healthy attached gingiva.

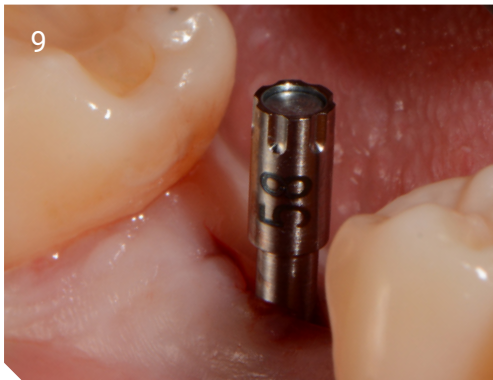
9. Osstell reading taken - now 75 ISQ.

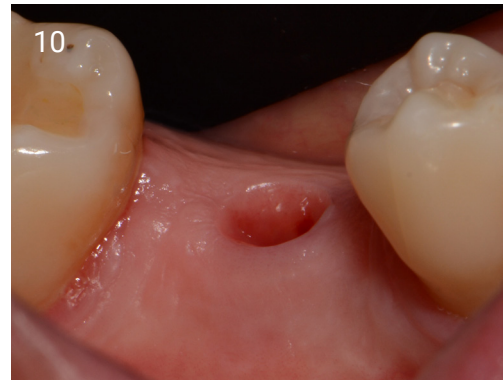
10. Healed peri-implant soft tissue.

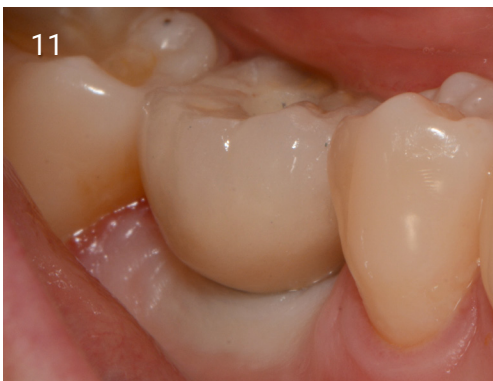
11. Loaded Case.
