# CASE STUDIES

**ethOss**<sup>®</sup>

# PERIODONTAL GRAFTING

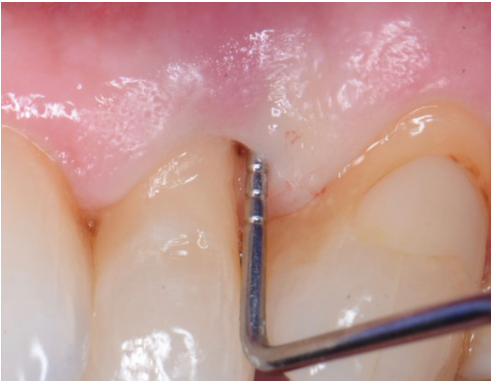
1. Probing showed an 8mm distal pocket

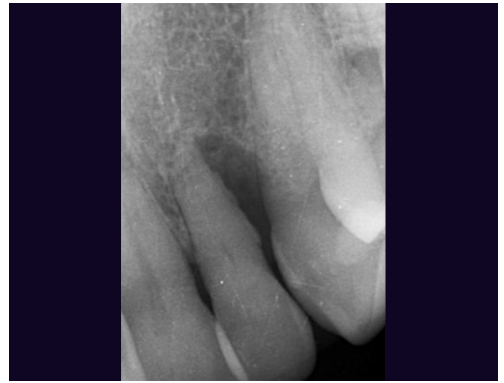
2. Radiograph shows large distal bone loss to the apex of the tooth, which is grade 3 mobile

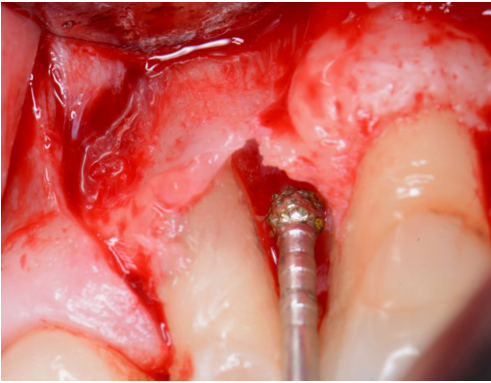
3. Flap is raised and bone defect was cleaned with EthOss® Degranulation Burs

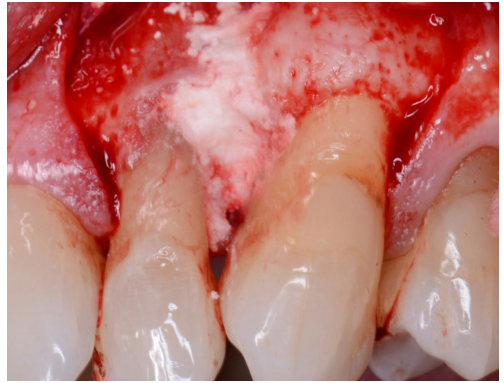
4. Site grafted with EthOss bone grafting material

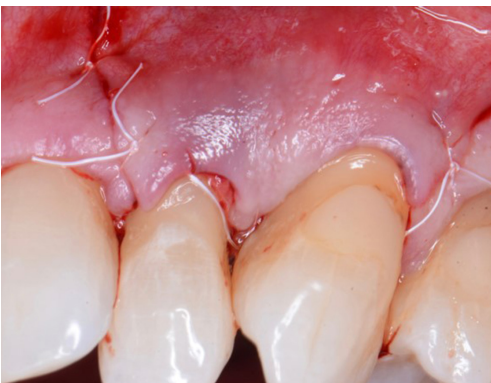
5. Flap is sutured closed

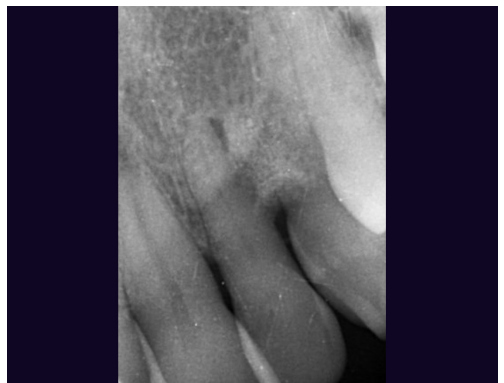
6. Radiograph showing site now grafted with EthOss bone grafting material

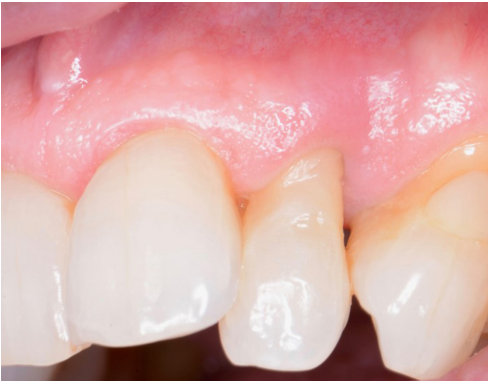
7. Loaded at 4 months - very solid but consideration around whether a better flap design could have improved soft tissue

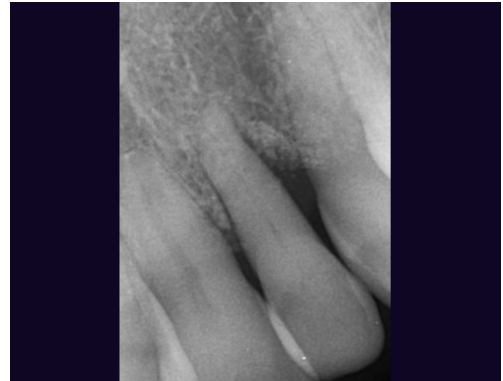
8. Loaded at 4 months - radiograph showing new bone regeneration
