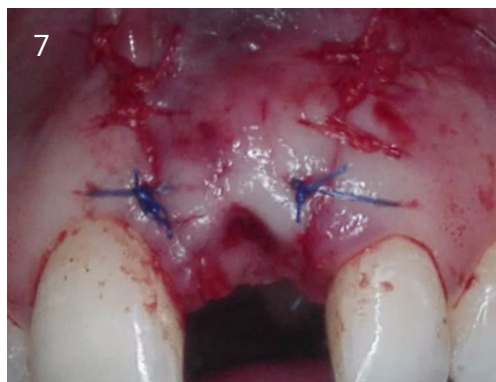
7. Graft sutured over with good soft tissue closure.

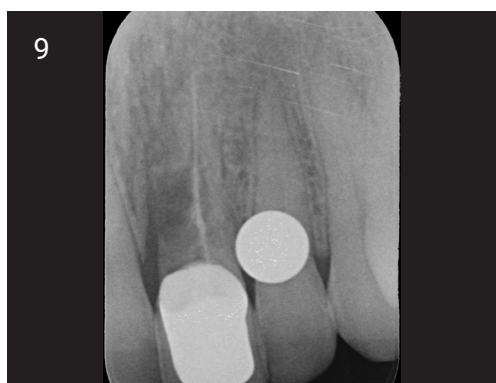
9. Radiograph pre-surgery showing extreme bone loss.

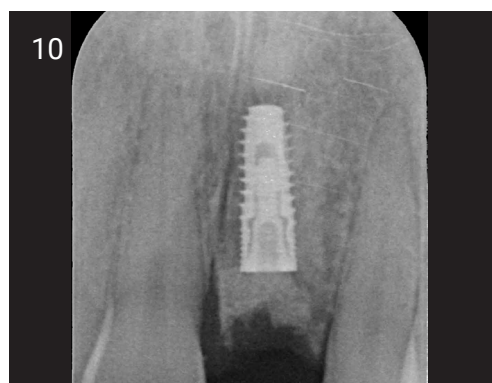
10. Radiograph post graft and implant placement.

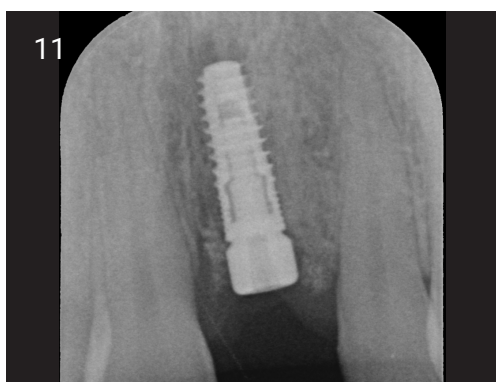
11. Implant with healing abutment and vertical bone growth (12 weeks).

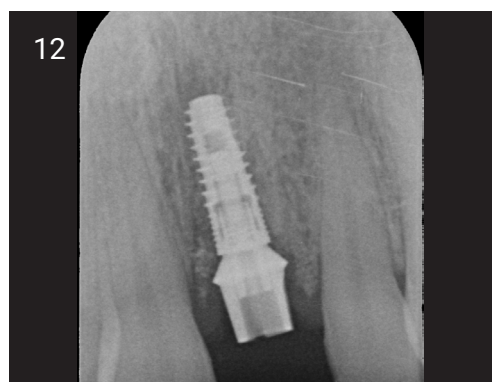
12. Implant with abutment showing even more vertical bone growth (16 weeks).
